DOT/FAA/CT-82/153
DOT/FAA/RD-82/85

Evaluation of Precision Approach Path Indicator (PAPI)

Final Report

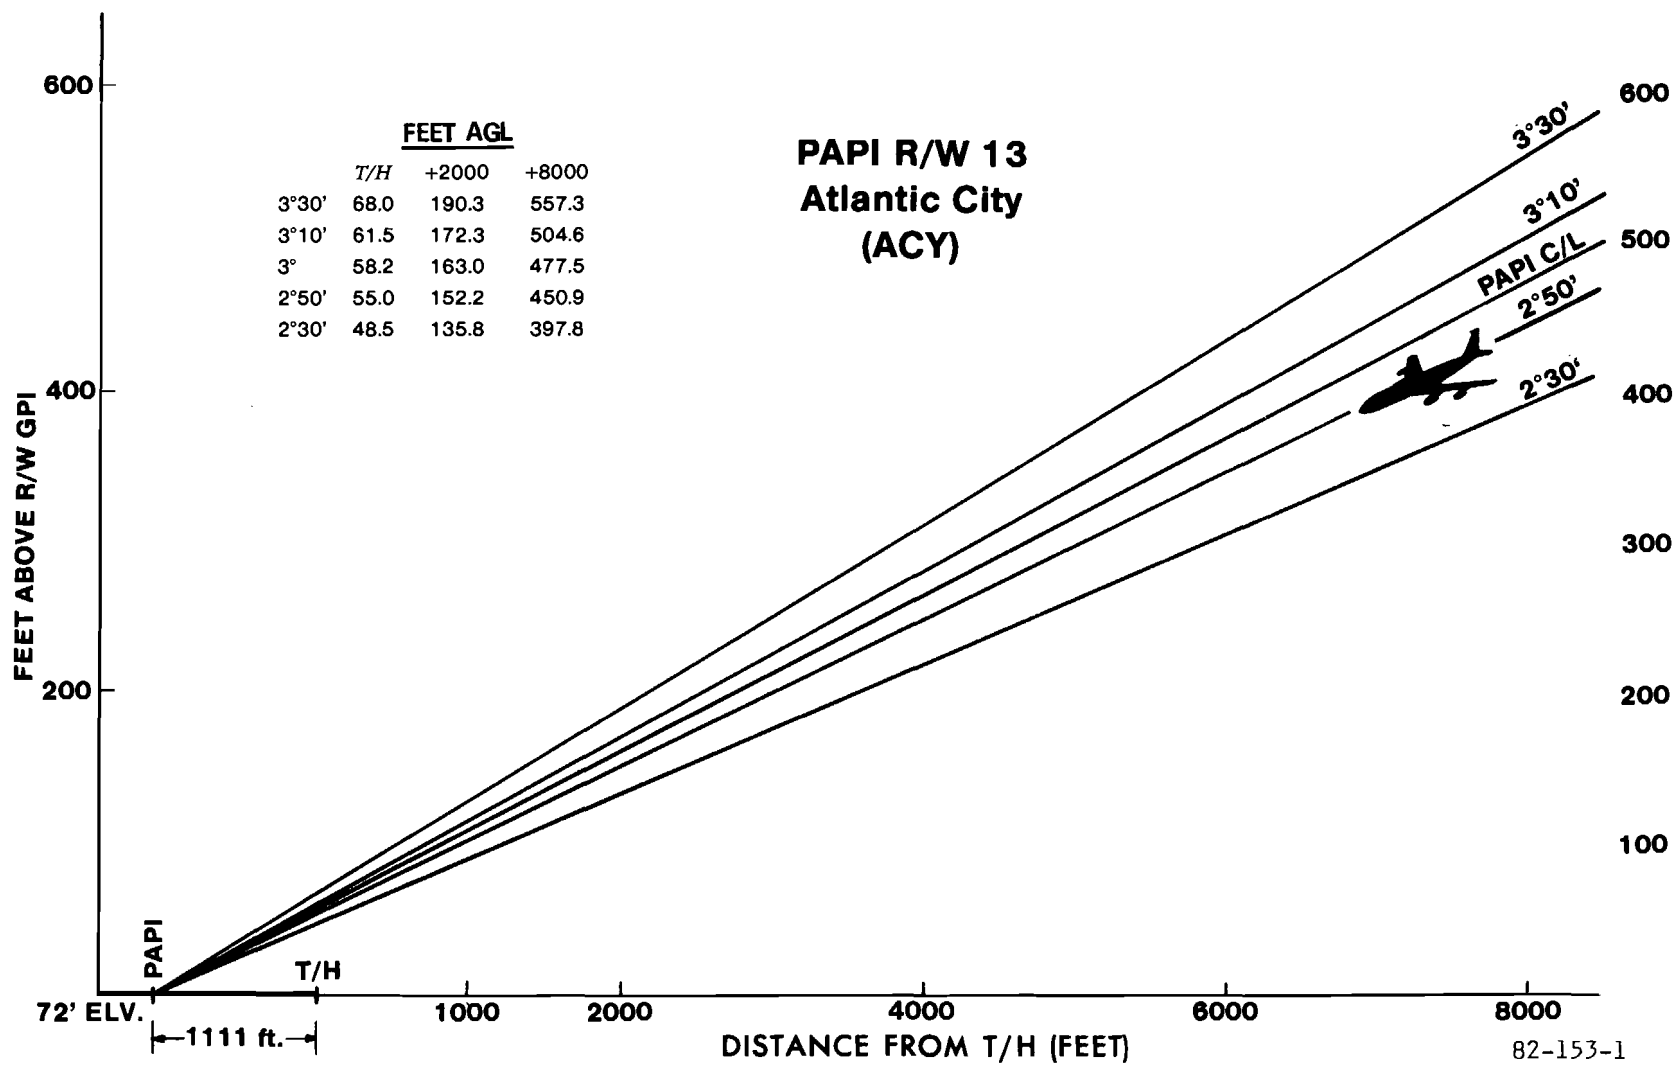
FIGURE 1. PAPI APPROACH PATH (SIDE VIEW)

The PAPI system consists of a bar of four light units (three lamps per unit) facing the approach end of the runway. Each unit is set at a slightly different angle (20 minutes apart) and emits a beam of high intensity light, the upper half showing white and the lower half showing red. Figure 1 depicts a side view of the signal sectors in the approach zone. As seen by the approaching pilot, it consists of a bar of four quick transition red/white light units whose on-glidepath signal (usually 3°) is two red and two white lights (figure 2). When the aircraft is slightly below glidepath (between 2° 50 minutes and 2° 30 minutes), the signal changes to three red and one white light. When the aircraft is further below glidepath (below 2° 30 minutes), a fly-up signal of four red lights is seen. Conversely, deviations above the glidepath will cause the red light units to turn successively white. In this configuration, the lights can be seen at about 5 miles from the threshold of the runway (in unlimited visibility) and the on-glidepath signal depth gradually reduces to approximately 6 feet at the threshold.

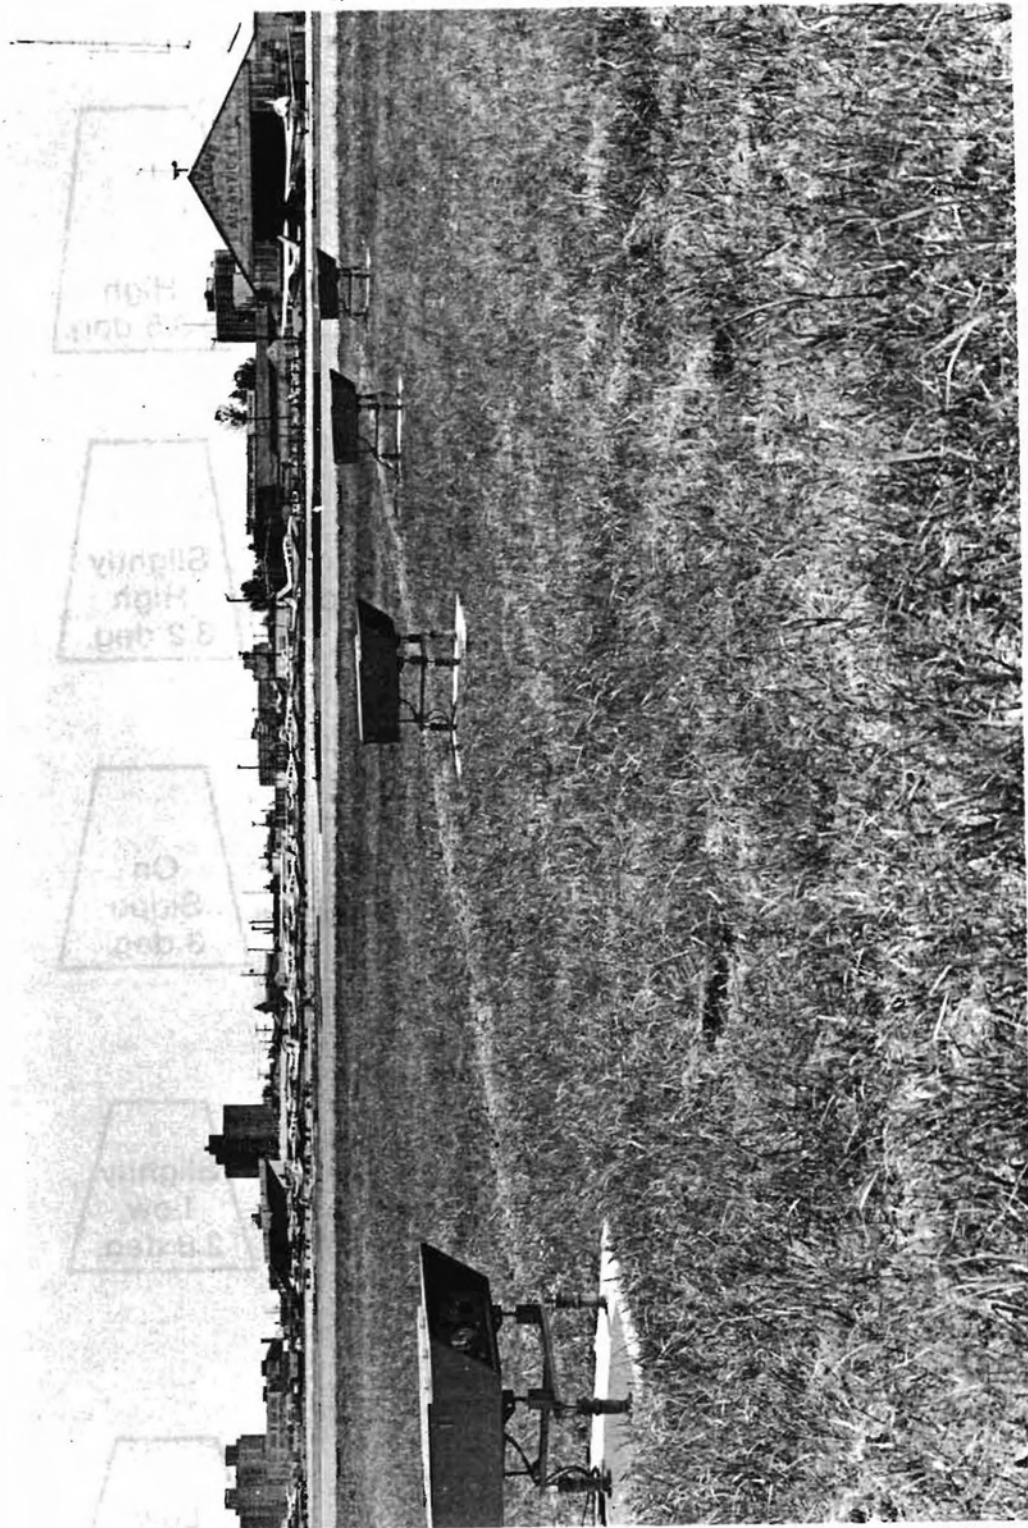
FIGURE 3. BARREL PAPI SYSTEM AT BADER FIELD

The physical configuration of the PAPI system (4 boxes) is shown in figure 3, each box being similar in appearance to the standard red/white VASI box. They require the same type and amount of power as required for a four-box VASI system and, therefore, there is no change in the power requirements if a PAPI system is to be substituted for a four-box VASI system. Most of the flight testing was accomplished on a model BLC MK 6 PAPI system (figure 4) manufactured by the Barrel Lighting Company, Limited of England. Some testing, however, was performed on early

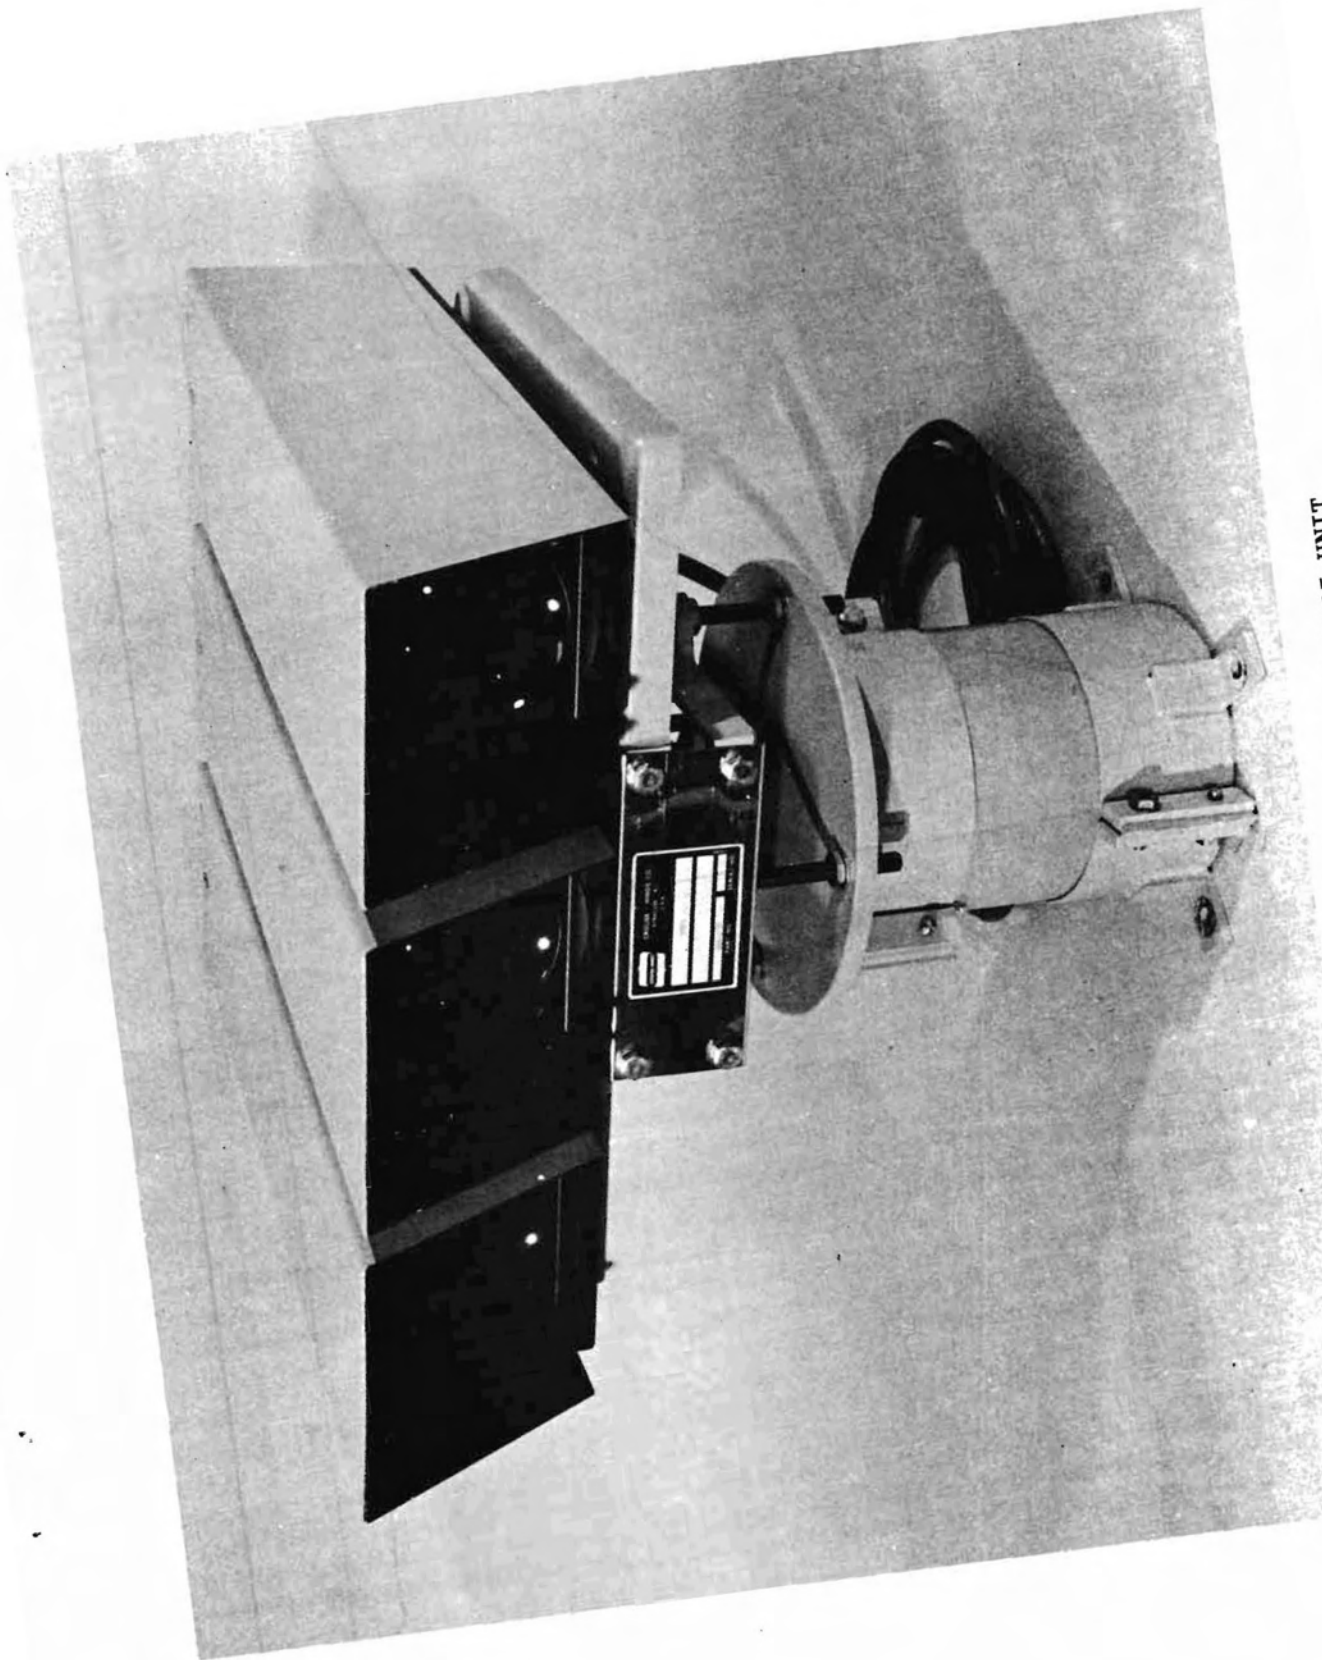
FIGURE 5. CROUSE-HINDS PAPI UNIT

versions of PAPI units built by ADB of Belgium and by Crouse-Hinds, Syracuse, New York (figure 5).

This freezing condensation problem is recognized by the manufacturers and the Barrel units have heaters installed close to the lenses in an attempt to prevent this condition. The Crouse-Hinds units are extremely compact and the heat from the lamps develops quickly to eliminate this condition within a few minutes after energization. Because this problem can be expected to occur with any PAPI unit, specifications should be written to include means for preventing such an occurrence.

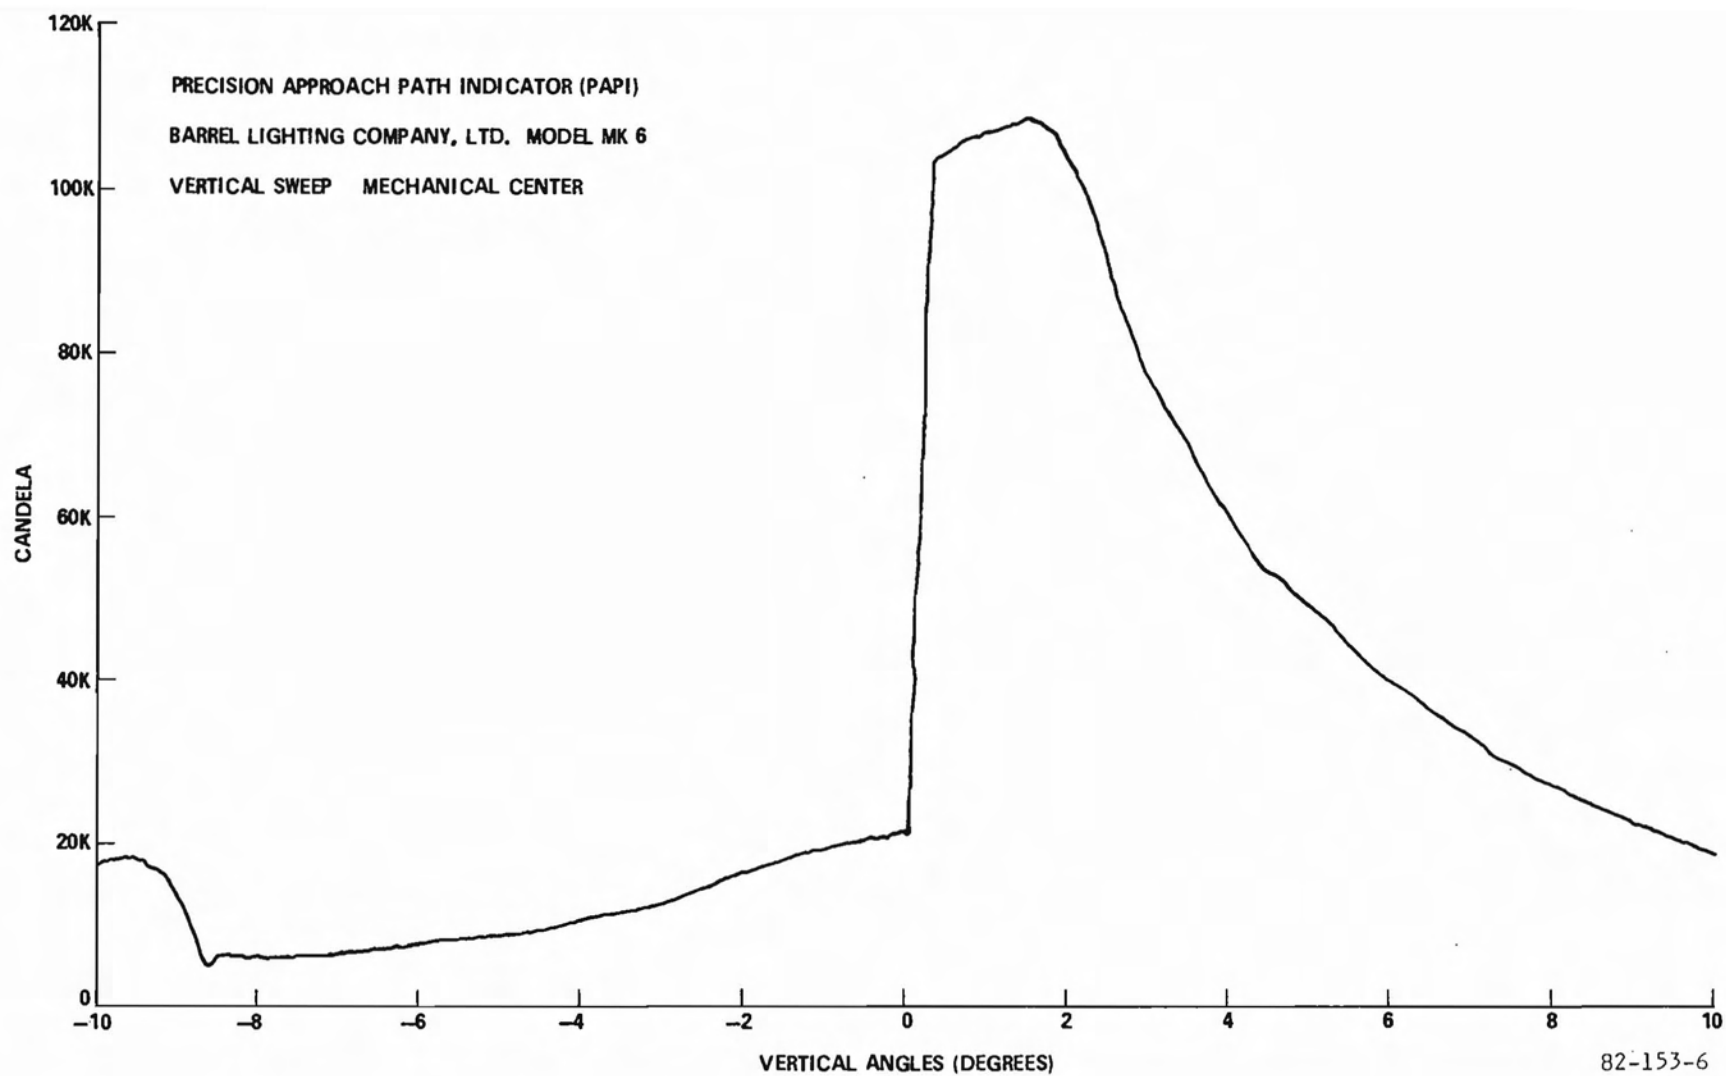
FIGURE 6. VERTICAL INTENSITY DISTRIBUTION CURVE

Photometric measurements were made on the Barrel Lighting Co. PAPI fixture. The lamps are standard 30 volt, 200 watt, 200PAR locomotive lamps. Horizontal and vertical intensity distribution measurements were obtained for the units. Figure 6 shows the vertical beam distribution of both the red and the white signals of one PAPI unit when measured from minus 10 degrees to a plus 10-degree elevation. It also displays the quick transition (approximately 3 minutes of arc) from one color to the other. Figures 7 and 8 show the horizontal intensity distribution of the white and red signals, respectively, taken at peak beam intensity. The peak intensity of the white signal, occurring at 1.5° elevation, was 112,000 candelas and the peak intensity of the red signal, occurring at 0° elevation, was 22,000 candelas. Transmittance tests were made on the red filters of the Barrel unit, and

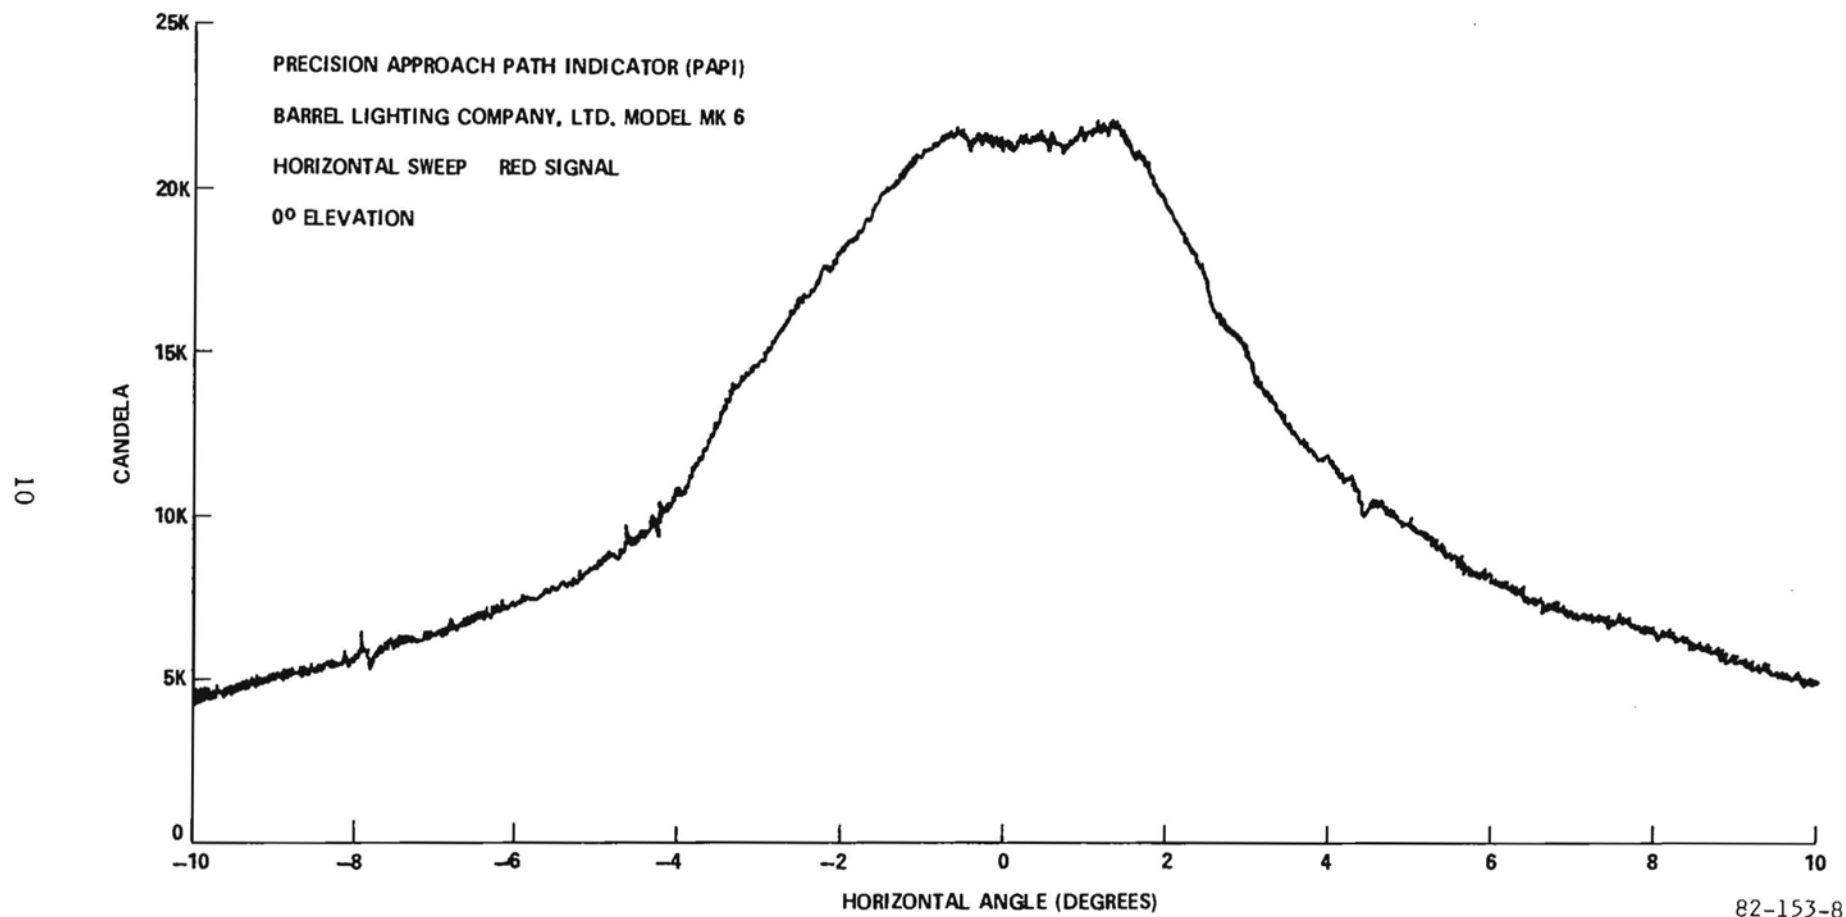
FIGURE 8. RED SIGNAL INTENSITY DISTRIBUTION CURVE

this was found to be 21 1/4 percent in the cold condition which meets acceptable standards.

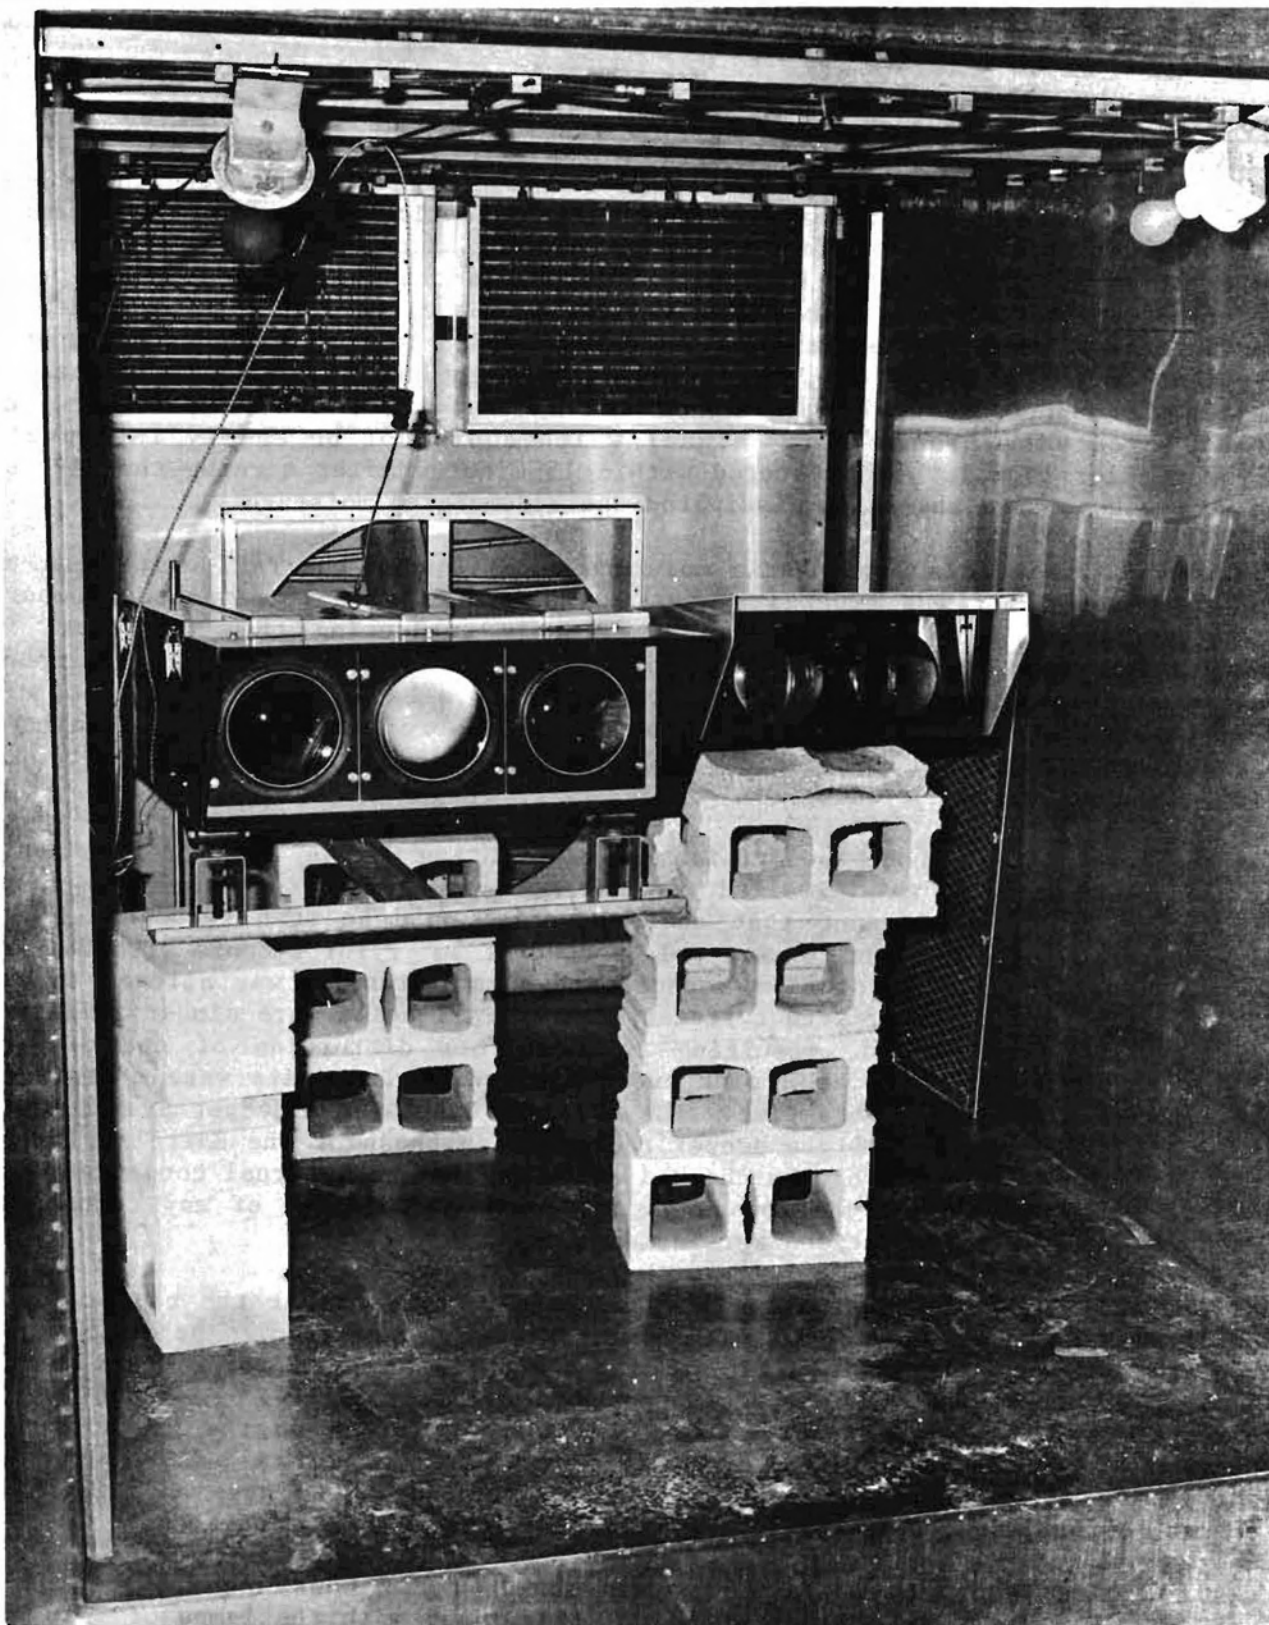
FIGURE 9. ENVIRONMENTAL TESTING OF PAPI UNITS

For the initial test, both the British Barrel Lighting Company Limited MK 6 and the Belgian ADB units were installed in the walk-in temperature/humidity chamber (figure 9) in such a manner that their signals could be seen through the glass viewing port. After the units were cold soaked at 30° F for 2 hours with the lamps deenergized, the chamber door was opened and warm humid air was allowed to enter the chamber. The exterior lens surfaces of both PAPI units were almost immediately covered with condensation, resulting in a uniform distortion of the projected signal that was perceived as a pink overall signal. The units were energized at 6.6 amperes intensity at this time. The ADB unit displayed a deeper pink hue since its red filters are normally a deeper red hue than those of the Barrel unit. The interiors of the boxes were then checked and virtually no internal condensation was found. Within 1/2 hour, the lenses of both units were clear of any condensation and normal signal presentations were evident.

One of each of the Barrel and the ADB PAPI units were placed in the temperature/humidity chamber (figure 9) in such a manner that their light signals were projected through the viewing port with the red/white transition zone clearly

displayed 24 feet from the units. Lines were marked on a wall at the precise location of the transition zone for each unit. Both units, with lamps deenergized, were then heat soaked for 24 hours at 131° F and 95 percent humidity. After the soaking, the units were energized and the position of the transition zone noted. The ADB unit transition zone had not shifted at all, although the zone was slightly less well defined. The Barrel unit transition zone had shifted upward 3/16 of an inch with the zone just as distinct as before the soaking. The lamps were left ON for 1/2 hour and then turned OFF for 1/2 hour. They were then turned back ON and it was found that the transition zones had not shifted. The units were then deenergized and left OFF for 24 hours at a normal room temperature and humidity. After this 24-hour period, the light transition zones were again checked and it was found that the Barrel unit transition zone had returned to its original position. The ADB unit transition zone displayed no evident shifting during the entire test procedure.

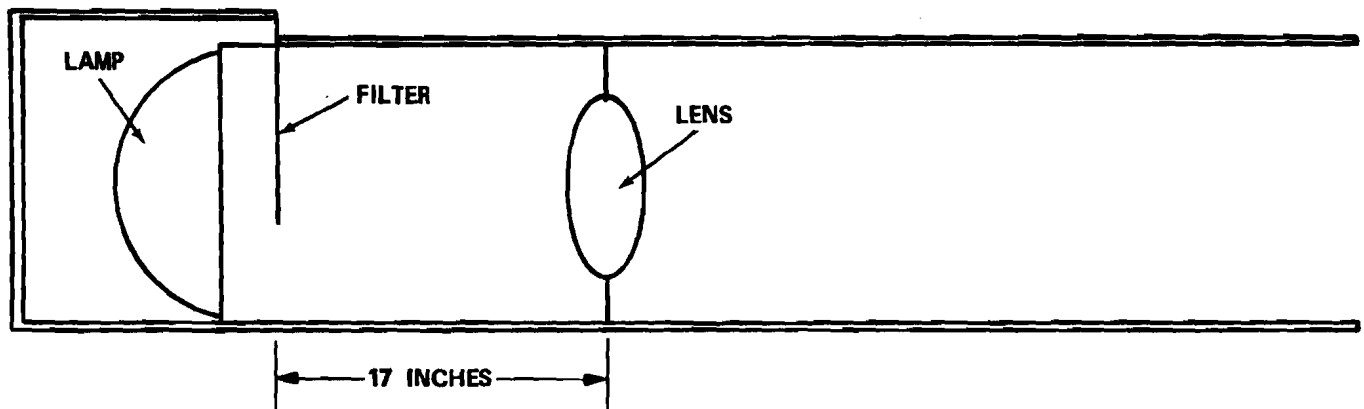
OPEN SLOT MODEL

The "open slot" model mounting arrangement of the optical components included unfluted red filters in their normal mounting positions, with the 6-inch lenses mounted at the focal length, 17 inches forward of the red filters. The normal 2-inch slotted front face of the VASI box was completely removed, leaving the front of the box open.

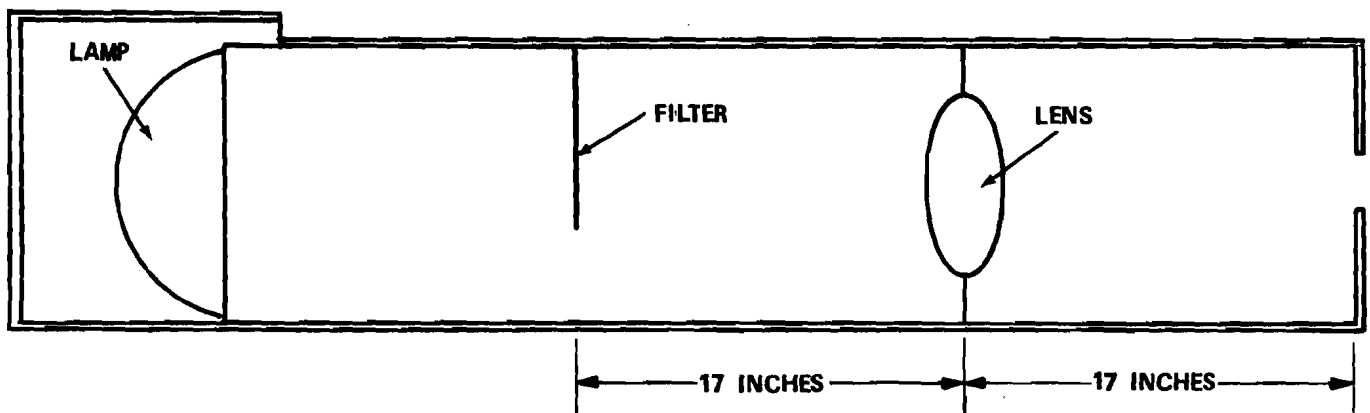
NARROW SLOT MODEL

The "narrow slot" model design required that the 6-inch lenses be moved forward so that the focal length plane was coincident with the normal 2-inch slot on the front of the box to insure maximum signal emission through the 2-inch slot. The lens,

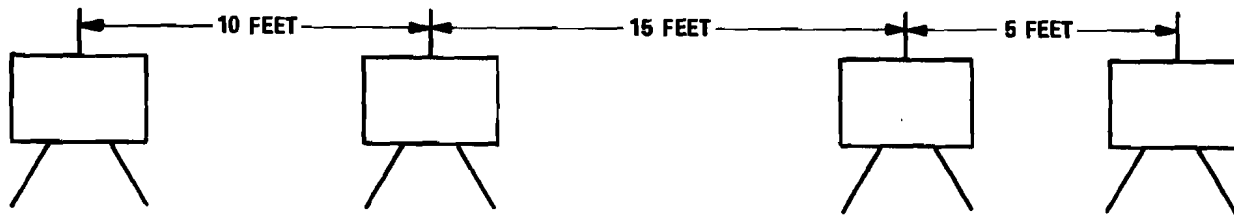
Additional flight testing was conducted to determine whether PAPI signals could be readily seen and resolved with individual PAPI units installed closer together than specified by the British (minimum spacing of 33 feet). Four Barrel PAPI units were installed at the Technical Center in the configuration shown below.

The spacing of the experimental arrangement was so constituted that individual pairs of units could be energized, in turn, to provide lateral spacings of 5, 10, 15, 20, 25, and 30 feet as desired. Approaches were flown, from extreme range, with an Aero Commander 680 aircraft, a Bell 206L helicopter, and a Sikorski S-76 helicopter to determine the maximum distances (range) at which signals from two PAPI light units could be resolved and identified as two distinct light sources. Known landmarks on the ground and distance measurement equipment (DME) in the aircraft were used to observe and record maximum resolution ranges for pairs of PAPI units with lateral spacings as indicated above. A conservative approach was taken in this test and resolution ranges were not established until the lights were judged to be sufficiently distinct so as to insure that an unfamiliar pilot could clearly determine that individual lights from the PAPI system could be seen separately. The flight tests were conducted in VFR weather conditions, in daylight and at night, with at least 4 1/2 nautical miles of visibility.

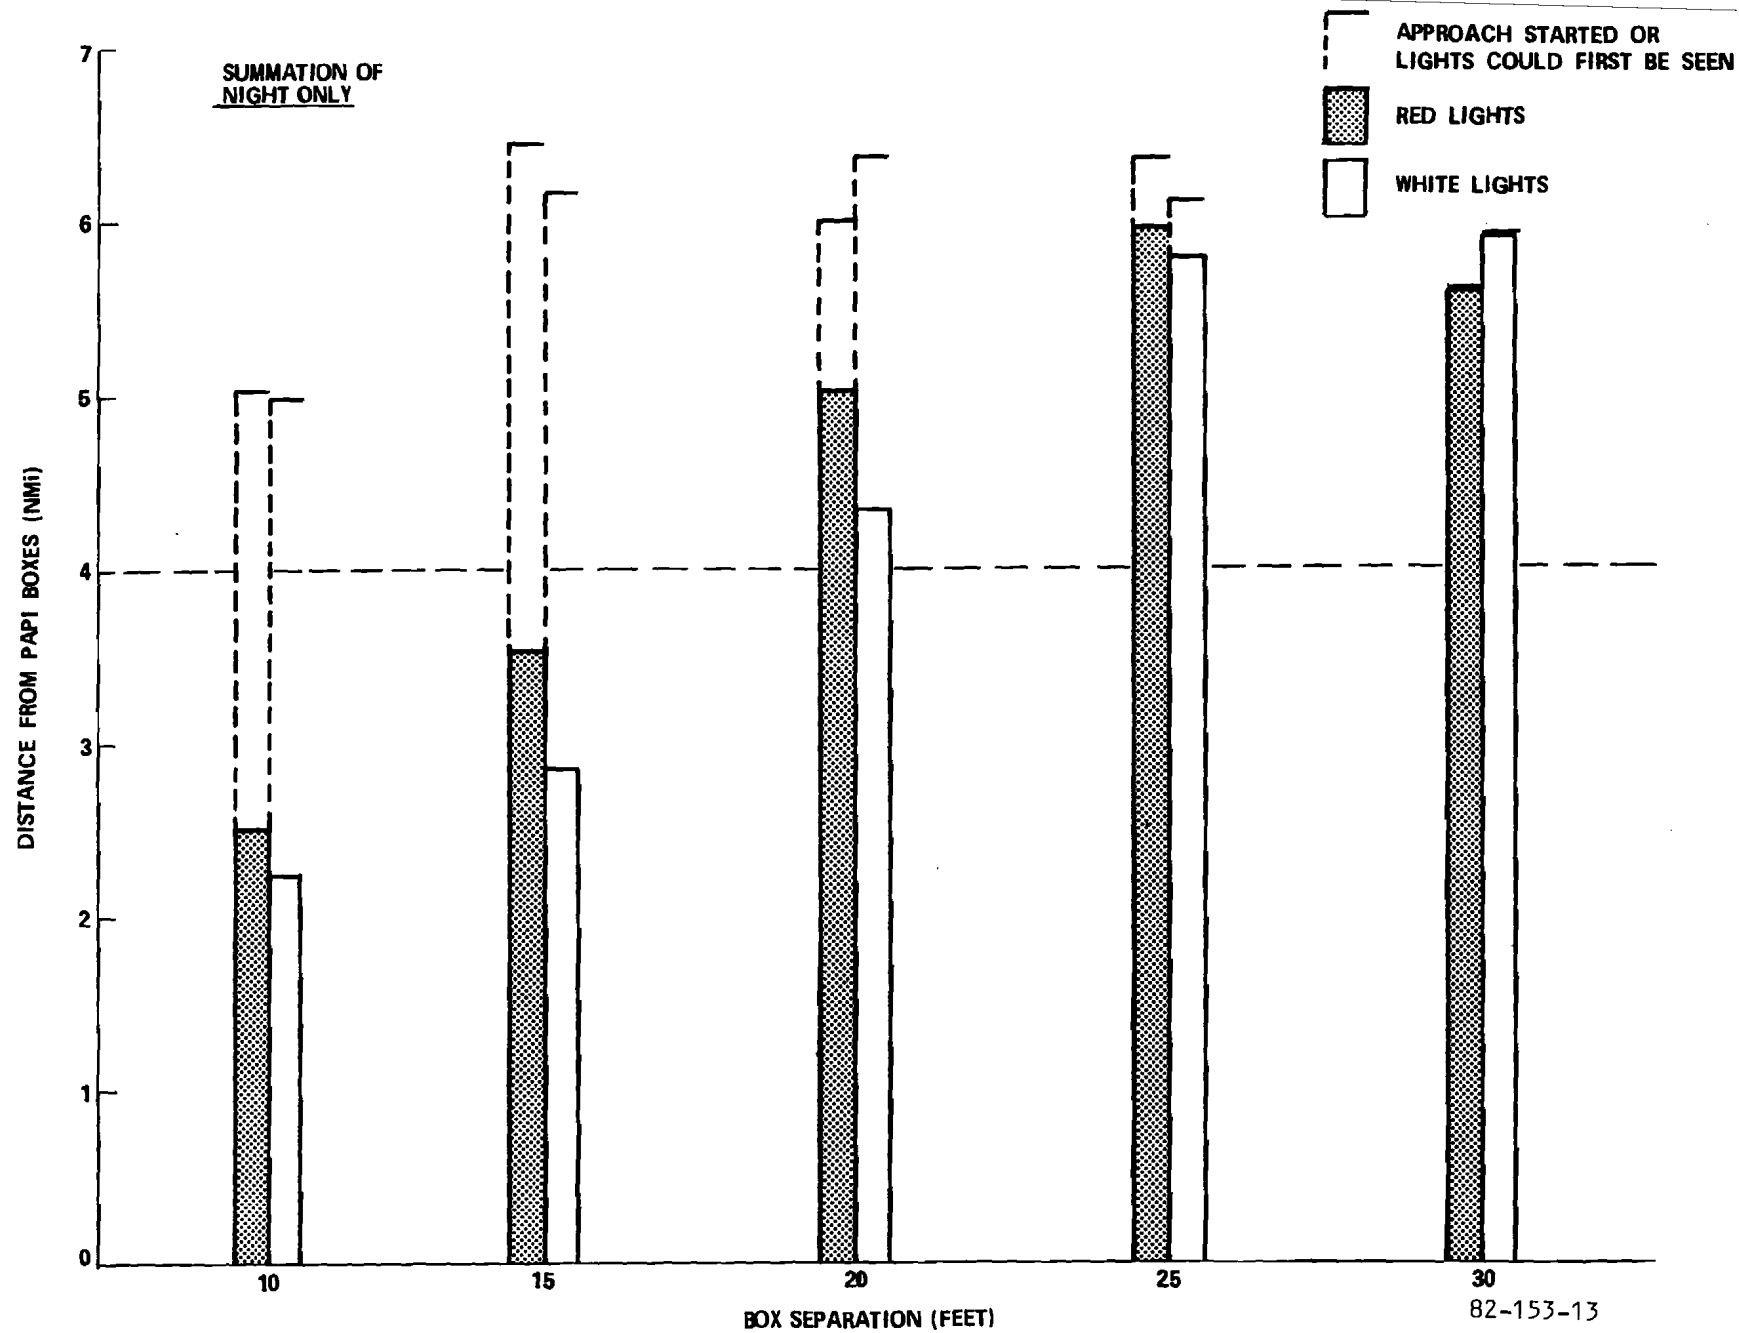
FIGURE 13. GRAPH OF NIGHTTIME RESOLUTION TESTS

NIGHTTIME TEST RESULTS. (Figure 13). Power supply current, at night, was set at 3.8 amperes, midway between the current values for intensity steps 2 and 3 on the standard five-step regulator. It had been determined, during the previous night flight testing of the PAPI system, that this intensity was preferred by the majority of pilots who flew the PAPI at the Technical Center. In each test session, it was determined that the pilots, at night, were able to resolve individual PAPI red and white light signals with spacing as close as 20 feet at ranges of 4 nautical miles. FAA Advisory Circular AC 150/5340-25, "Visual Approach Slope Indicator (VASI) Systems," specifies 4 nautical miles as the minimum useable range for a standard four-box VASI. Lateral spacing of less than 20 feet resulted in determined resolution ranges of less than the required 4 nautical miles and were judged to be inadequate.

It follows from the above determinations, with regard to both night and day conditions, that lateral spacing of PAPI units installed at smaller General Aviation airports could be reduced to as little as 10 feet and still provide adequate guidance within ranges of 2 to 3 miles from the runway threshold.

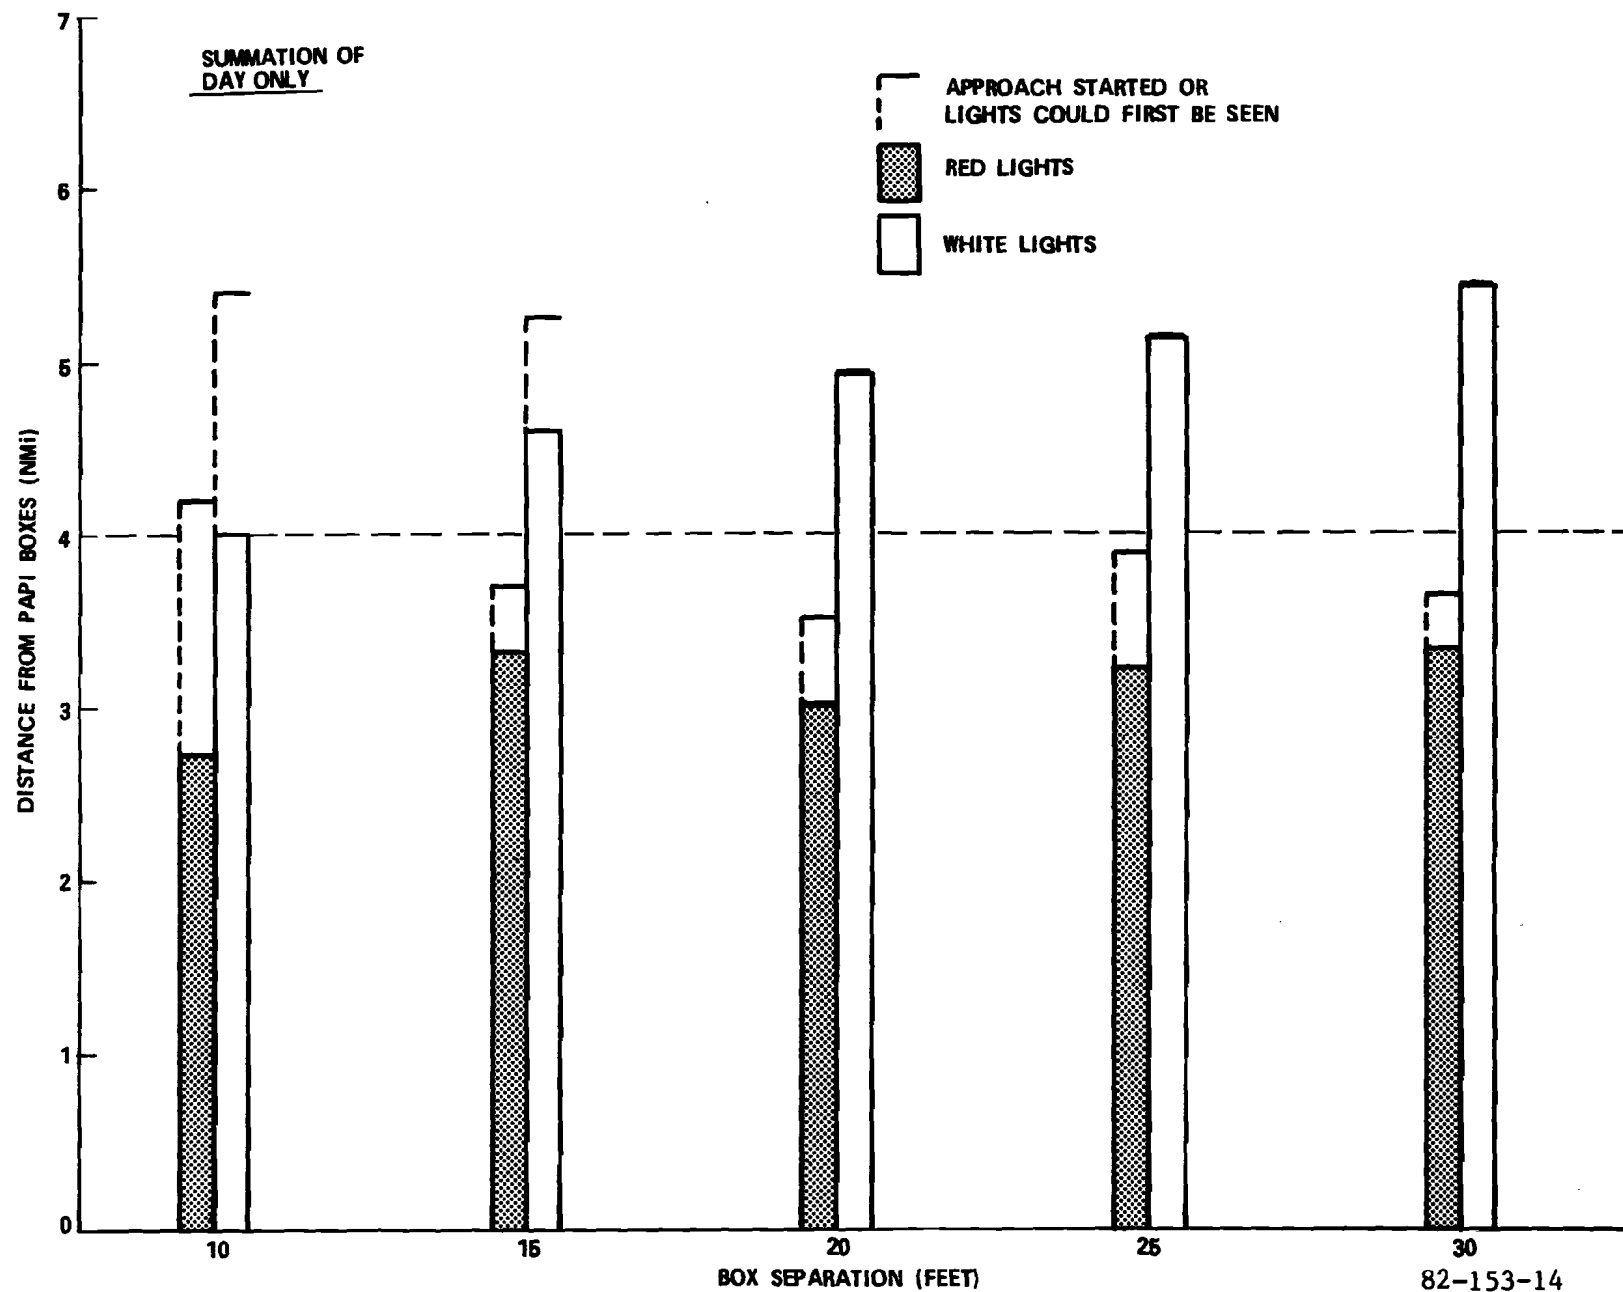
FIGURE 14. GRAPH OF DAYTIME RESOLUTION TESTS

DAYTIME TEST RESULTS. (Figure 14). Power supply current, during daytime, was set at 6.6 amperes which is the current value for intensity step 5 on the standard five-step regulator. Pilots were barely able to resolve the PAPI red light signal at 4-nautical mile range with the greatest lateral spacing of 30 feet. In fact, resolution ranges for the red signals were relatively constant at slightly greater than 3 nautical miles, regardless of lateral spacings less than 30 feet. This should not be construed to mean that a full four-box PAPI system could not be used at a 4-nautical mile range, in daylight, since a pilot familiar with the system could easily determine his long range relationship to glide path by counting the discernible white lights of the system.

The average resolution range of the PAPI white lights, during daytime, exceeded 4 nautical miles even when the lateral spacing of PAPI units was as close as 10 feet.

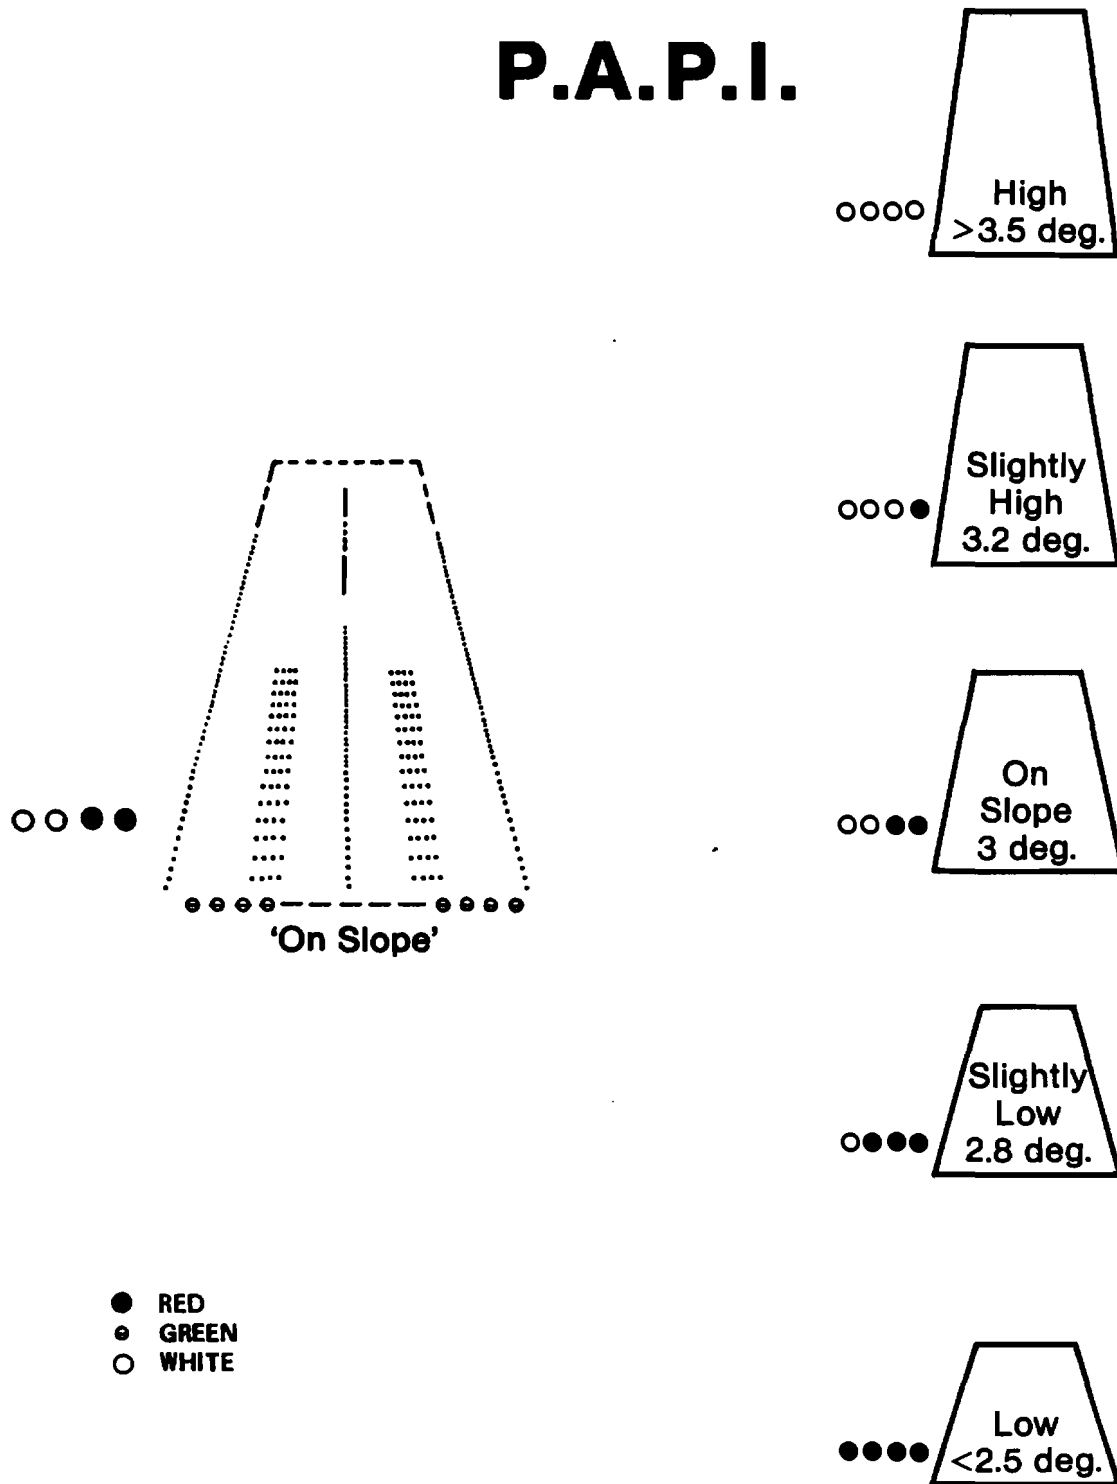
FIGURE C-3. DESCRIPTIVE DIAGRAM

Remember: Two red and two white means on glide slope -
increased white means above glide slope,
increased red means below glide slope.
